May 1966 THE NAVAL AVIATION SAFETY REVIEW

Flying in turbulence

By T. F. Laughlin

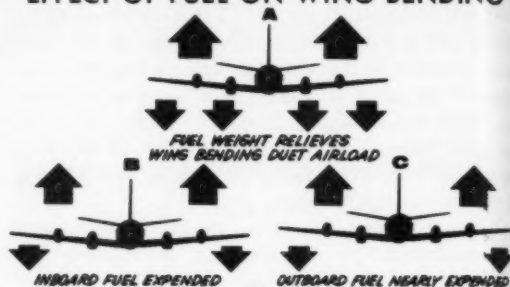
Fig. 7

Fuselage loads, on the other hand, depend not only on the magnitude of the payload, but its distribution. Thus adherence to the recommended loading schedules is mandatory to avoid excessive structural loads. Where, as previously stated, the maximum wing loads occur in combination with the carrying of maximum payload, the addition of fuel has a profound effect on the actual wing loads experienced in flight. Figure 7 illustrates how the weight of fuel carried in the wing acts to relieve the wing bending caused by the airload. An illustration of this sort emphasizes the requirement of adherence to the recommended fuel loading and management as defined in the applicable airplane flight manual. The example shown applies to a contemporary four-engine cargo/transport airplane.

It can be seen that the change in wing bending resulting from consumption of fuel can be expressed

EFFECT OF FUEL ON WING BENDING

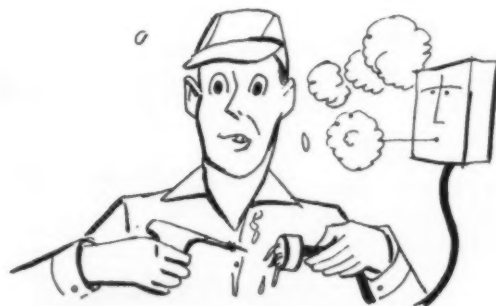
... soldered a wire to a pin in an electrical connector that has ceramic inserts without using a heat-sink.

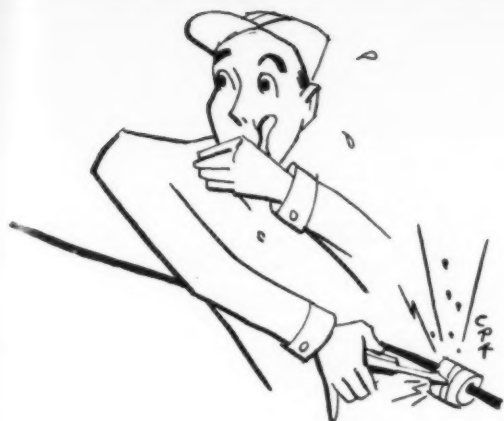
... broken a ceramic insert in an electrical connector by prying the two pieces apart with a screwdriver.

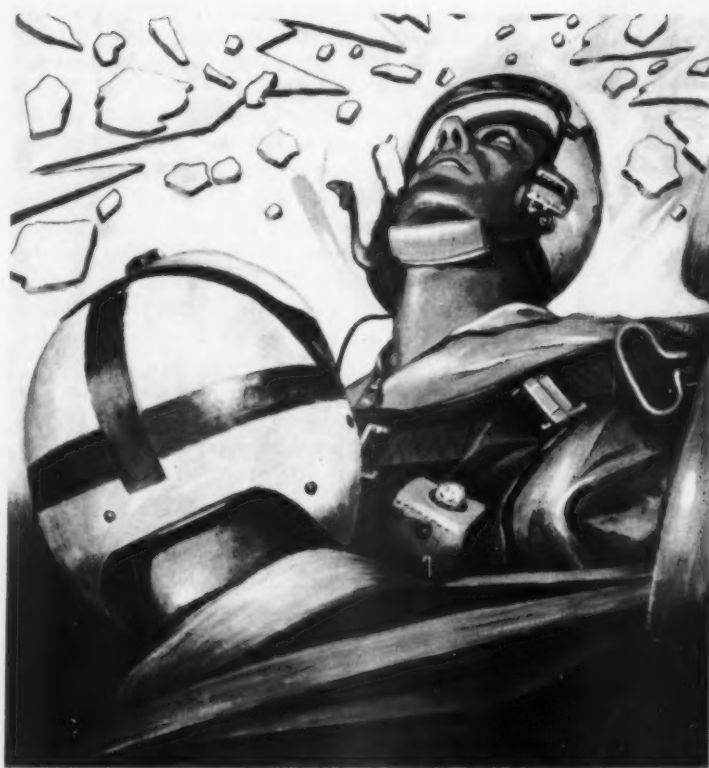
As decompression occurred, copilot's head was jerked forcibly into slipstream.

SHORTLY after a TA-3B leveled at assigned flight level 290 on a scheduled logistic flight, the right hand forward canopy enclosure panel adjacent to the copilot failed and blew out, explosively decompressing the cockpit and cabin spaces.

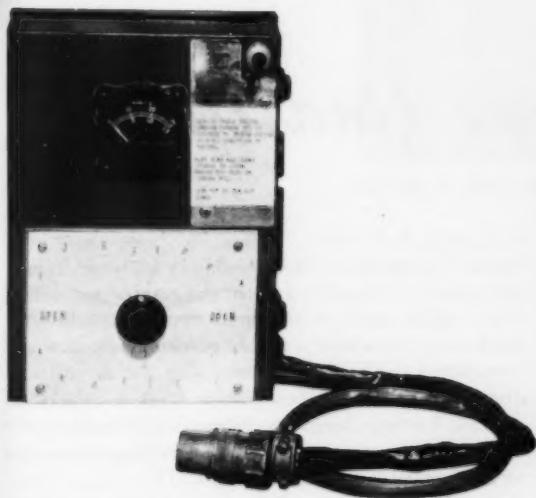
LB11A stray voltage and continuity tester made from a rocket continuity tester and a two-decked rotary switch. In use it is plugged into the wing, connecting aircraft pins to the switch and meter in series and then to ground.

- finally he pointed out to ordnancemen that by operating the test switch on the 114 tester control panel and simultaneously operating the test switch on the programmer they had been merrily burning out the programmer.

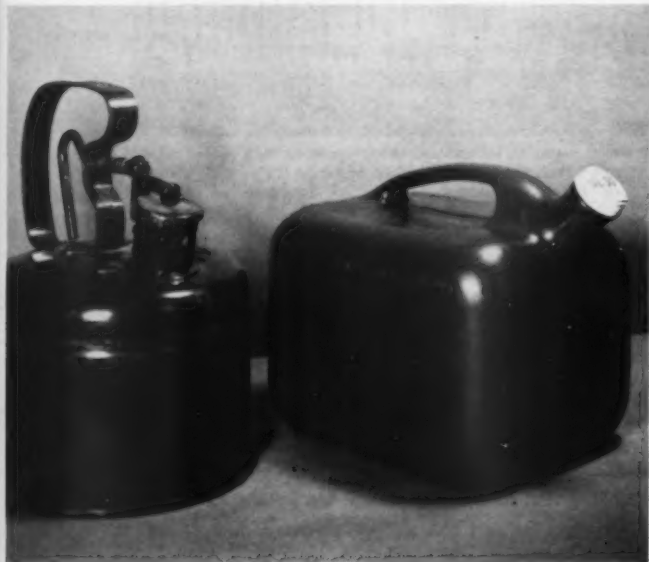
Metal can, left, is approved flammable liquid container.
Plastic container, right, is hazardous!

DON'T use plastic containers for flammable liquids! The National Fire Protection Association warns that flammable liquids are being stored in polyethylene plastic containers which were designed for water, bleaches, fruit juices, tea, milk and such liquids. Unfortunately, some manufacturers of these containers are advertising their use for all liquids, including gasoline and other flammables.

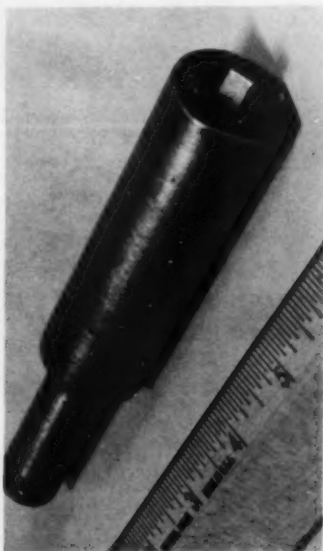
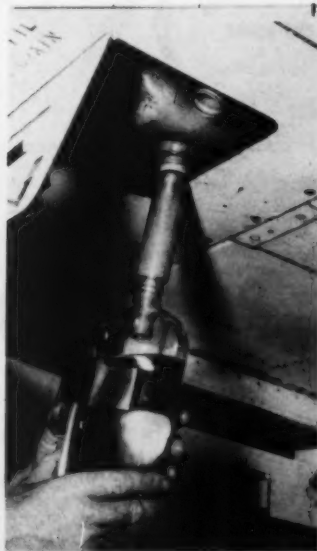
A fuel sample is taken by placing the tool into the bottle and then pressing the other end of the tool against the drain fitting. The tool is used to take samples from low point drains of the wing, fuselage and droptank fuel cells.

Machined brass fuel drain tool, left, enables easy, reliable sampling, right.
